Technical Evaluation of the Gold King Mine Incident

San Juan County, Colorado

U.S. Department of the Interior
Bureau of Reclamation
Technical Service Center
Denver, Colorado

October 2015

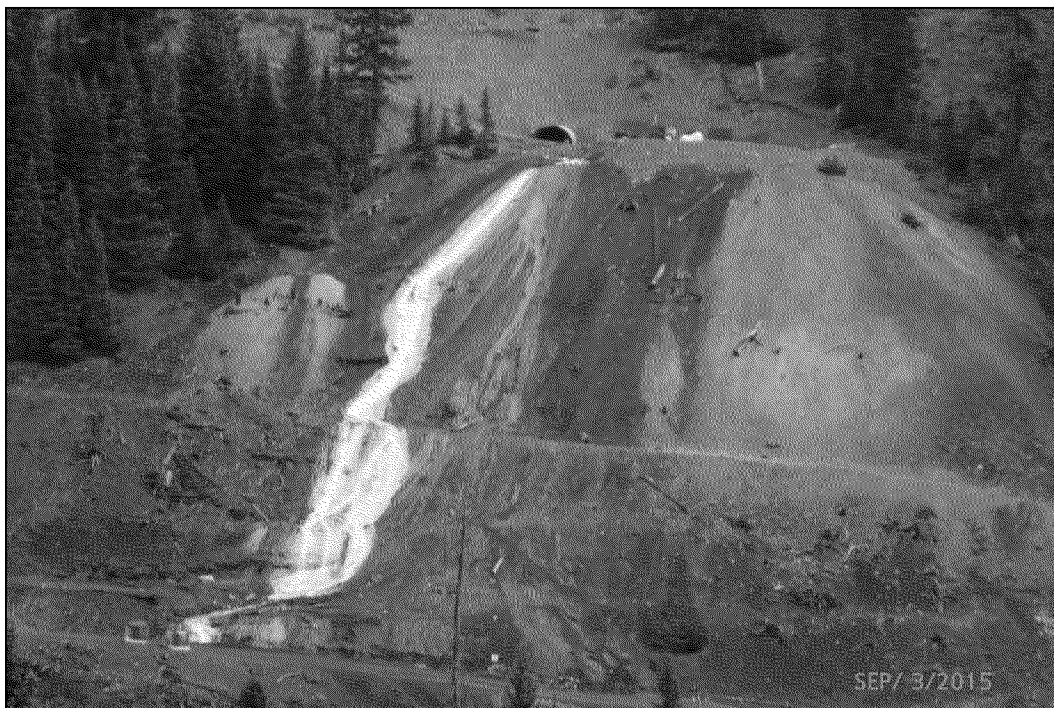
Figure 11.—Photograph showing acid drainage flowing out of the Red and Bonita Mine on September 3, 2015.

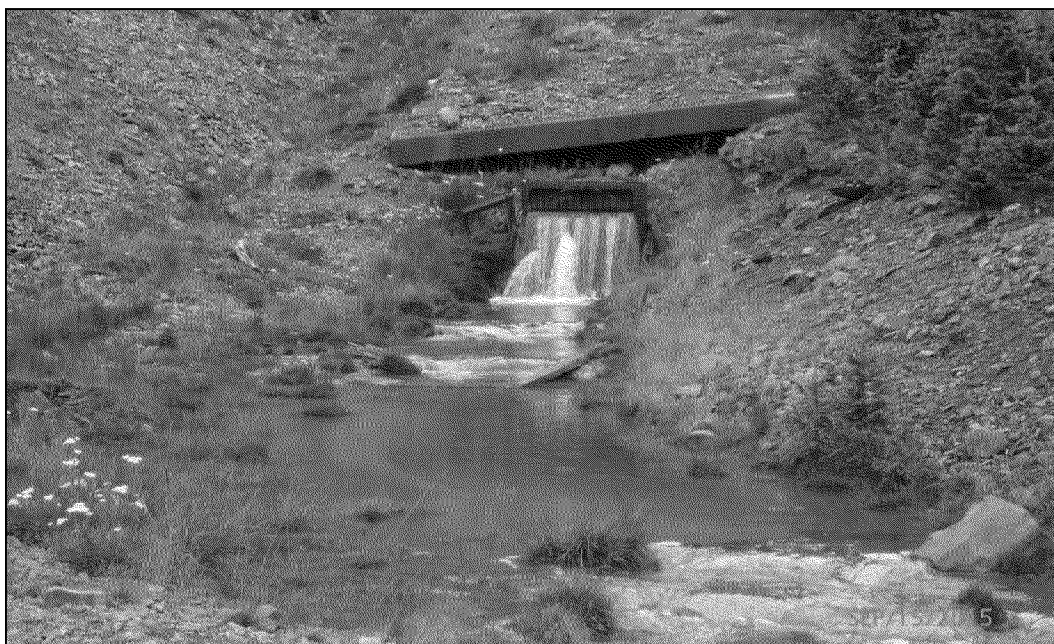
Figure 12.—Photograph taken on September 15, 2015, of drainage from the Silver Ledge Mine, which is located south of the Gold King Mine.

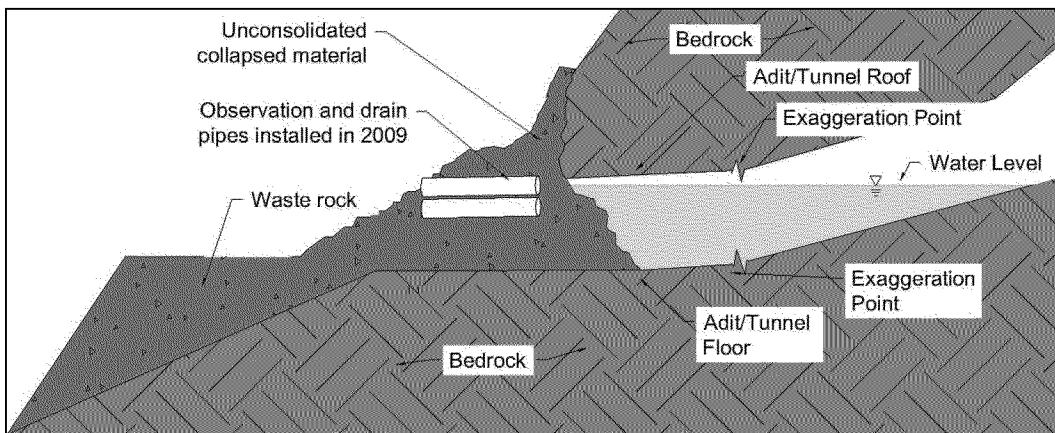
Figure 40.—Cross-section illustration showing the condition of the adit that was assumed by the EPA OSC and the abandoned mine experts from DRMS for use in planning to open the adit (not to scale). The “exaggeration point” means the right side of the drawing has an exaggerated vertical scale in order to show the 1% uphill slope of the adit. If drawn without exaggeration, the uphill slope of the adit would not be obvious on the drawing.
